Lean & Clean

Case Study

Facility: Carlson Engineered Composites

Location: Winnipeg, Manitoba

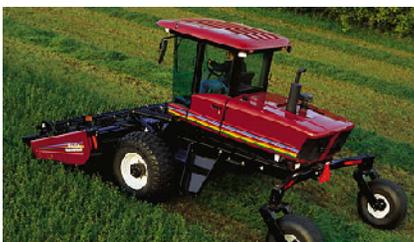
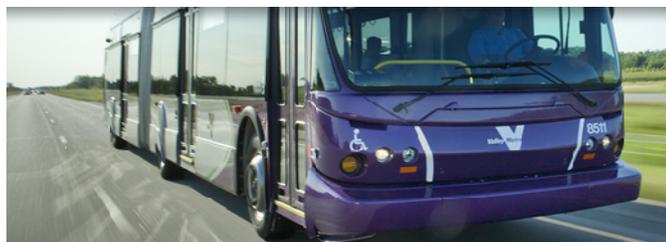
Carlson presently manufactures fibre glass components in open and closed (RTM, light RTM, compression and VARTM) moulds. Depending on customer needs, fibre glass components are gel coated, prepared, and painted.
